SUZUKI

Service Bulletin

Subject: OIL TANK CAP VENT

Bulletin No: GENERAL-13

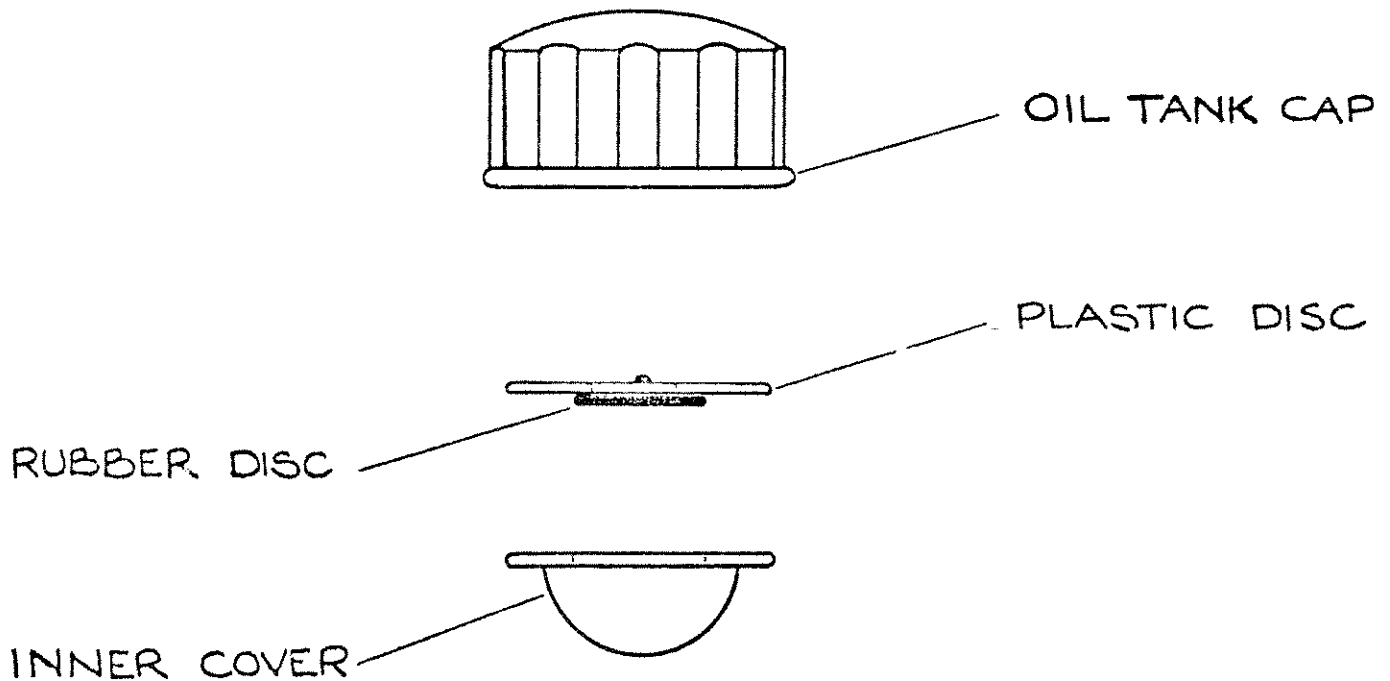
CORRECT INSTALLATION

There is a possibility that certain units of earlier models may have the breather valve in the oil tank cap installed incorrectly by the owner.

As illustrated below the flat rubber disc should be on the tank, or lower side, of the white plastic breather plate.

Please check the installation of this item on all applicable models that you may service. Obviously, failure to correct this problem could result in oil starvation and possible engine seizure.
