SUZUKI

Service Bulletin

Bulletin No: GENERAL-15

Subject: CLUTCH RATTLE ON TWIN CYLINDER
MODELS

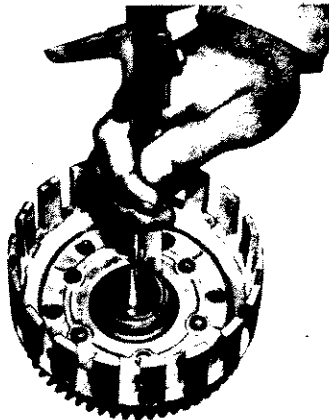
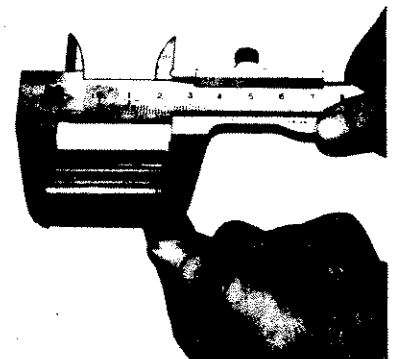
PROBLEM: Distinct rattle in the right primary case when the engine is idling, clutch lever released transmission in neutral. Noise worsens as the engine warms up. Noise disappears when the clutch lever is pulled.

CAUSE: The usual cause of this problem is the clutch housing "walking" on the transmission countershaft. The housing has too much axial play because of normal wear on the thrust side of the clutch hub.

CORRECTION: Disassemble the clutch and measure the difference in length of the spacer and the thickness of the clutch housing. This difference is the amount of clearance that the clutch housing can slide back and forth on the shaft.

MODEL	AXIAL PLAY	
	MAXIMUM	MINIMUM
X6, TC250, T200, TC200, T250, T350, T305, TC305	.007 inch	.003 inch
S32	.008 inch	.004 inch
T10	.006 inch	.004 inch
T500	.007 inch	.002 inch

If the measurement is more than the maximum, rub one end of the clutch spacer on a honing stone until the difference is near the minimum above. Don't use a file or grinder. Don't overdo it, or the clutch will not release.

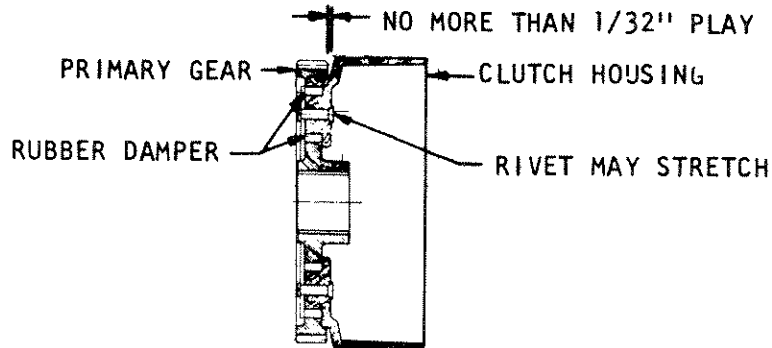
- A. The clutch housing/primary gear is a riveted assembly. There are rubber dampers which cushion the drive shock between these two parts. If the rivets stretch or the dampers soften, the clutch housing will wobble and make the same noise. Try to separate the two parts with your hands.

There should be less than 1/32 inch play between the two parts. Don't try to tighten the rivets. Instead, replace the assembly.

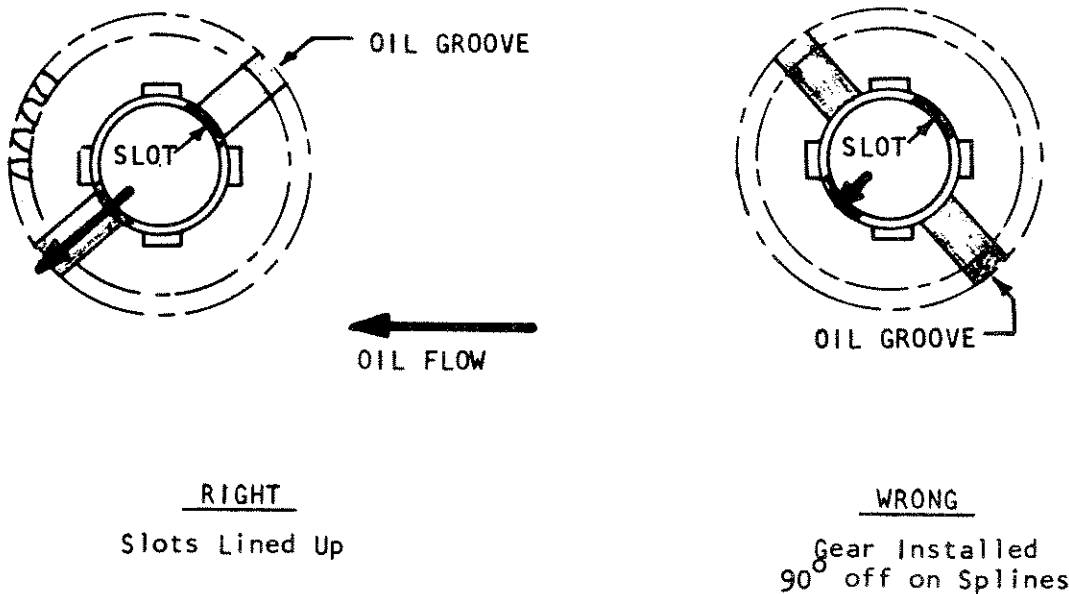
- B. Check the clutch hub nut and the primary pinion nut for tightness. Use a torque wrench when tightening these critical nuts.
- C. The X6, TC250, T200, TC200, T250, T305, TC305, T350, clutch housing is fitted with the kickstart drive gear on its backside. Be sure that the oil grooves in the gear are matched with the slots in the clutch bearing sleeve. Otherwise, the thrust face of the housing will prematurely wear due to lack of oil.

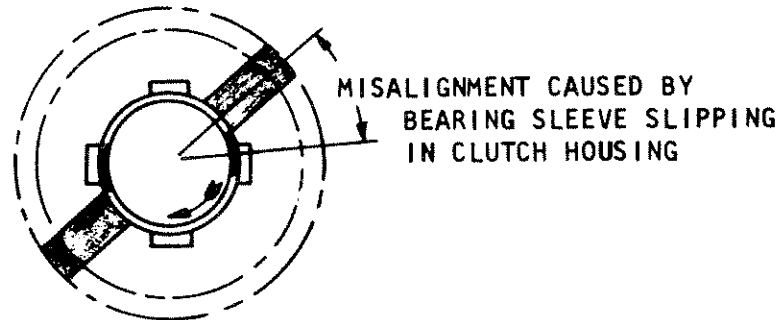
WRONG

Bearing has seized on shaft, causing sleeve to slip in housing.

- D. If the transmission oil level is too low, or if extreme heat is present in the clutch assembly, the clutch housing bearing will seize on the transmission driveshaft. The engine will stop suddenly, and the inertia of the rolling motorcycle will cause the clutch bearing sleeve, which is pressed into the housing, to spin in the housing. After it frees up, the clutch will work well. However, the thrust surface of the clutch housing will starve for oil and wear too quickly, again causing this "rattling" noise.
- E. Another possible cause is transmission oil level too low. Or the transmission oil viscosity is incorrect. The correct type is a 20W-40 multigrade detergent.
