SUZUKI

Service Bulletin

Bulletin No: GENERAL-8

Subject: ADJUSTING HORNS

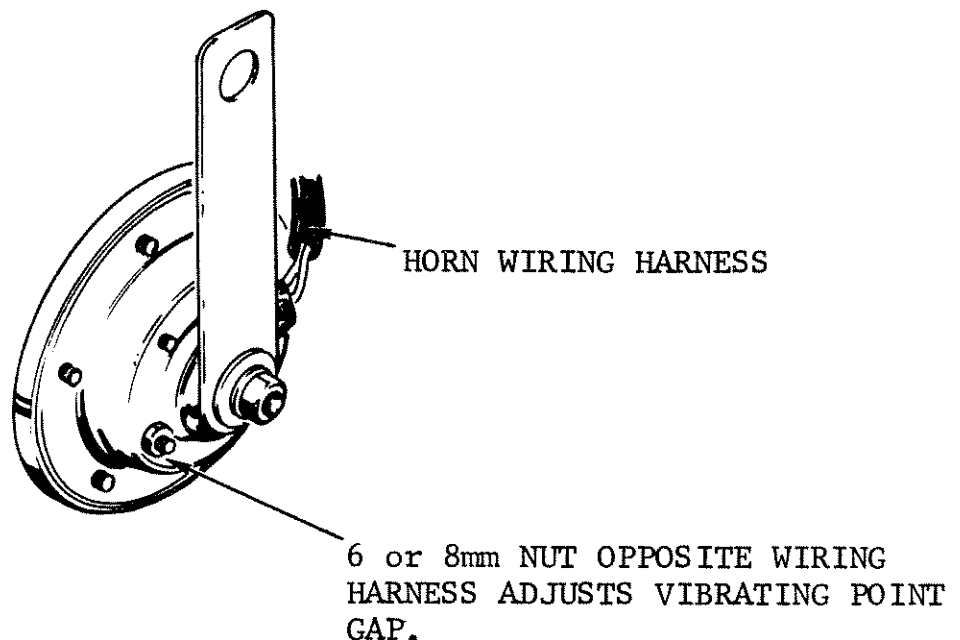
PROBLEM: The horn won't operate.

- CAUSES:**
- A. On all units, the horn is battery-operated. Make sure the battery is fully charged.
 - B. Check the horn button by disconnecting the green wire at the horn and grounding it. The horn should honk. NOTE: Turn the main switch on.
 - C. The horn is out of adjustment.

CORRECTION: To adjust the horn, turn the small nut on the back or front with a 6 or 8mm wrench. Push the horn button while adjusting for greatest volume.

NOTE: Turn the nut clockwise to narrow the vibrating point gap.
Turn the nut counterclockwise to widen the vibrating point gap.
